WO-A-0090

Tarakhil Thermal Power Plant – HDPE Fire Water Distribution
Piping Assessment Report

April 2, 2013

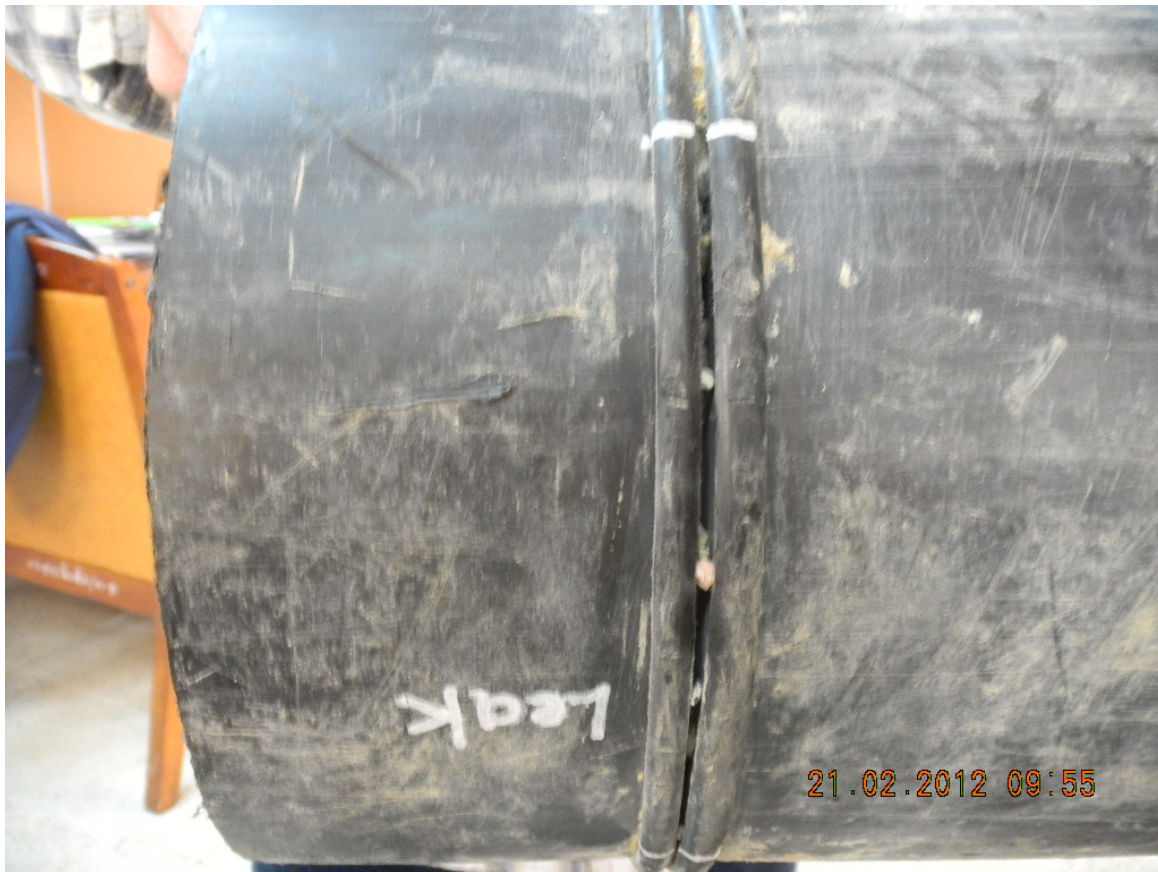
During the March 26, 2013 meeting, the focus of discussion was about two (2) items: Item 1, "How did the joints fail?" and Item 2, "What is the main cause of the failures?" [REDACTED] confirmed that B&V had studied these two (2) items and examined several failed heat-fused joints. It was discovered there was only partial fusing in the joints and that portions of the failed fuses had "bare HDPE surfaces," as described by [REDACTED], that were unaffected by the heat fusion process. [REDACTED] in a March 27, 2013 telephone conversation with Tt, said B&V "had concerns that inadequate heat was used in the heat-fusion process on some of the HDPE joints." An example of a failed heat-fused joint is shown below in Figure 1, "Failed HDPE Heat-Fused Joint."

Figure 1 – Failed HDPE Heat-Fused Joint (Courtesy B&V)

It is unknown at this point, how many of the existing estimated 436 heat-fused joints (See Table 1, “Number of Valves and Fittings in the System”) in the HDPE piping are inadequately fused (See Table 2, “Number of Joint Failures within the System”). The data in Table 1 and Table 2 have been populated based on information and estimates available for the system provided by others.

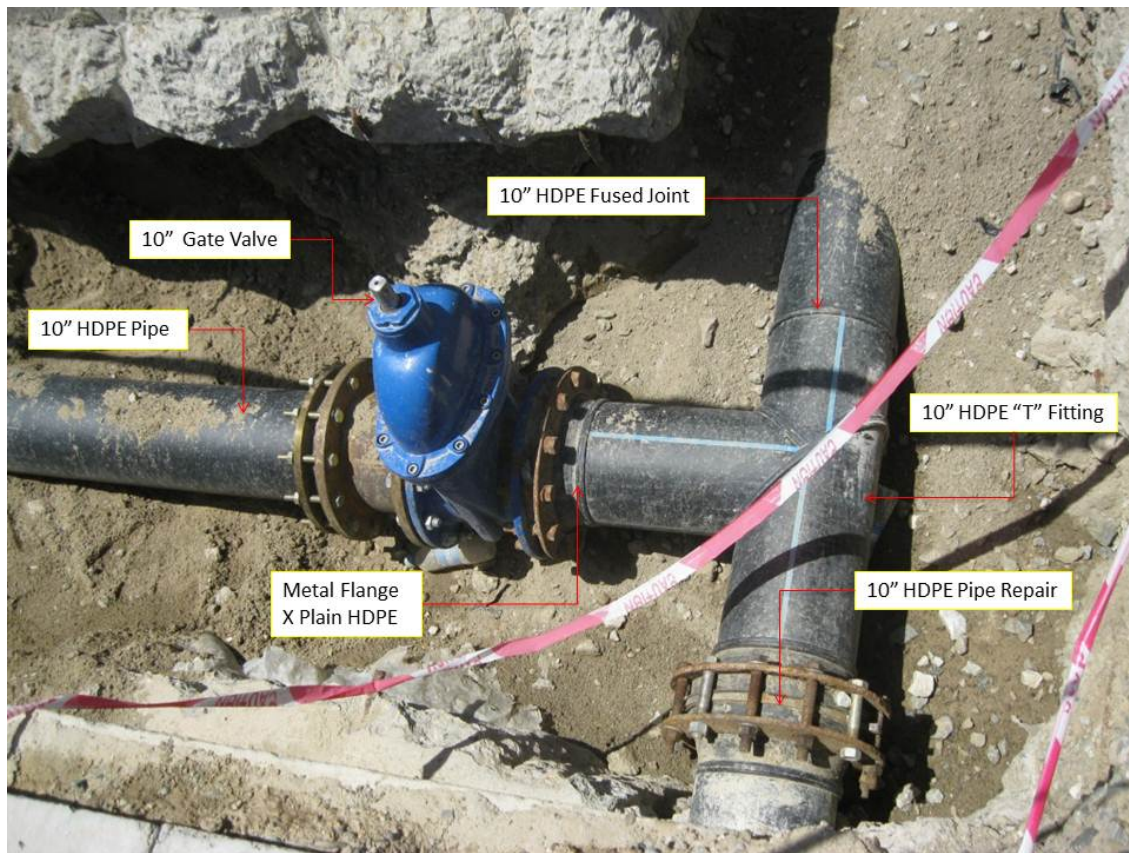
Repairs documented as “near tees and elbows” may have actually been work done on the flange connections because most of the HDPE pipe gate valves are located near tee and elbow fittings. It took a photograph of a repair done on an HDPE heat-fused joint and the HDPE-metal flange fitting that was used to transition from HDPE to the metal flange of the gate valve when on site in June 2012, see Figure 2, “Excavated HDPE Pipe Repairs” below.

Figure 2 – Excavated HDPE Pipe Repairs

DABS reported that all excavated and reheated fused repairs to leaking HDPE piping have held. B&V coordinated these repairs to be completed by Kabul Amo Water Supply & Construction Company (KAWCC). As previously shown in Figure 1, "Failed HDPE Heat Fused Joint," is a photograph of an HDPE heat-fused joint failure that [REDACTED] B&V, said was typical to other failed joints he had seen. It was told B&V had used a "clamping harness" to repair several leaking HDPE pipe joints. [REDACTED] B&V, provided Tt with a manufacturer's cut sheet of the harness he said was used to repair three (3) HDPE pipe joints. The clamping device is a spit-sleeve fitting manufactured by Vitalic, Style 995. The sleeve has rubber seal gaskets on both ends that are squeezed when the sleeve bolts are tightened to create a water tight sleeve around the HDPE heat-fused joint. It offers an alternative to the reheated fused joint repair method.

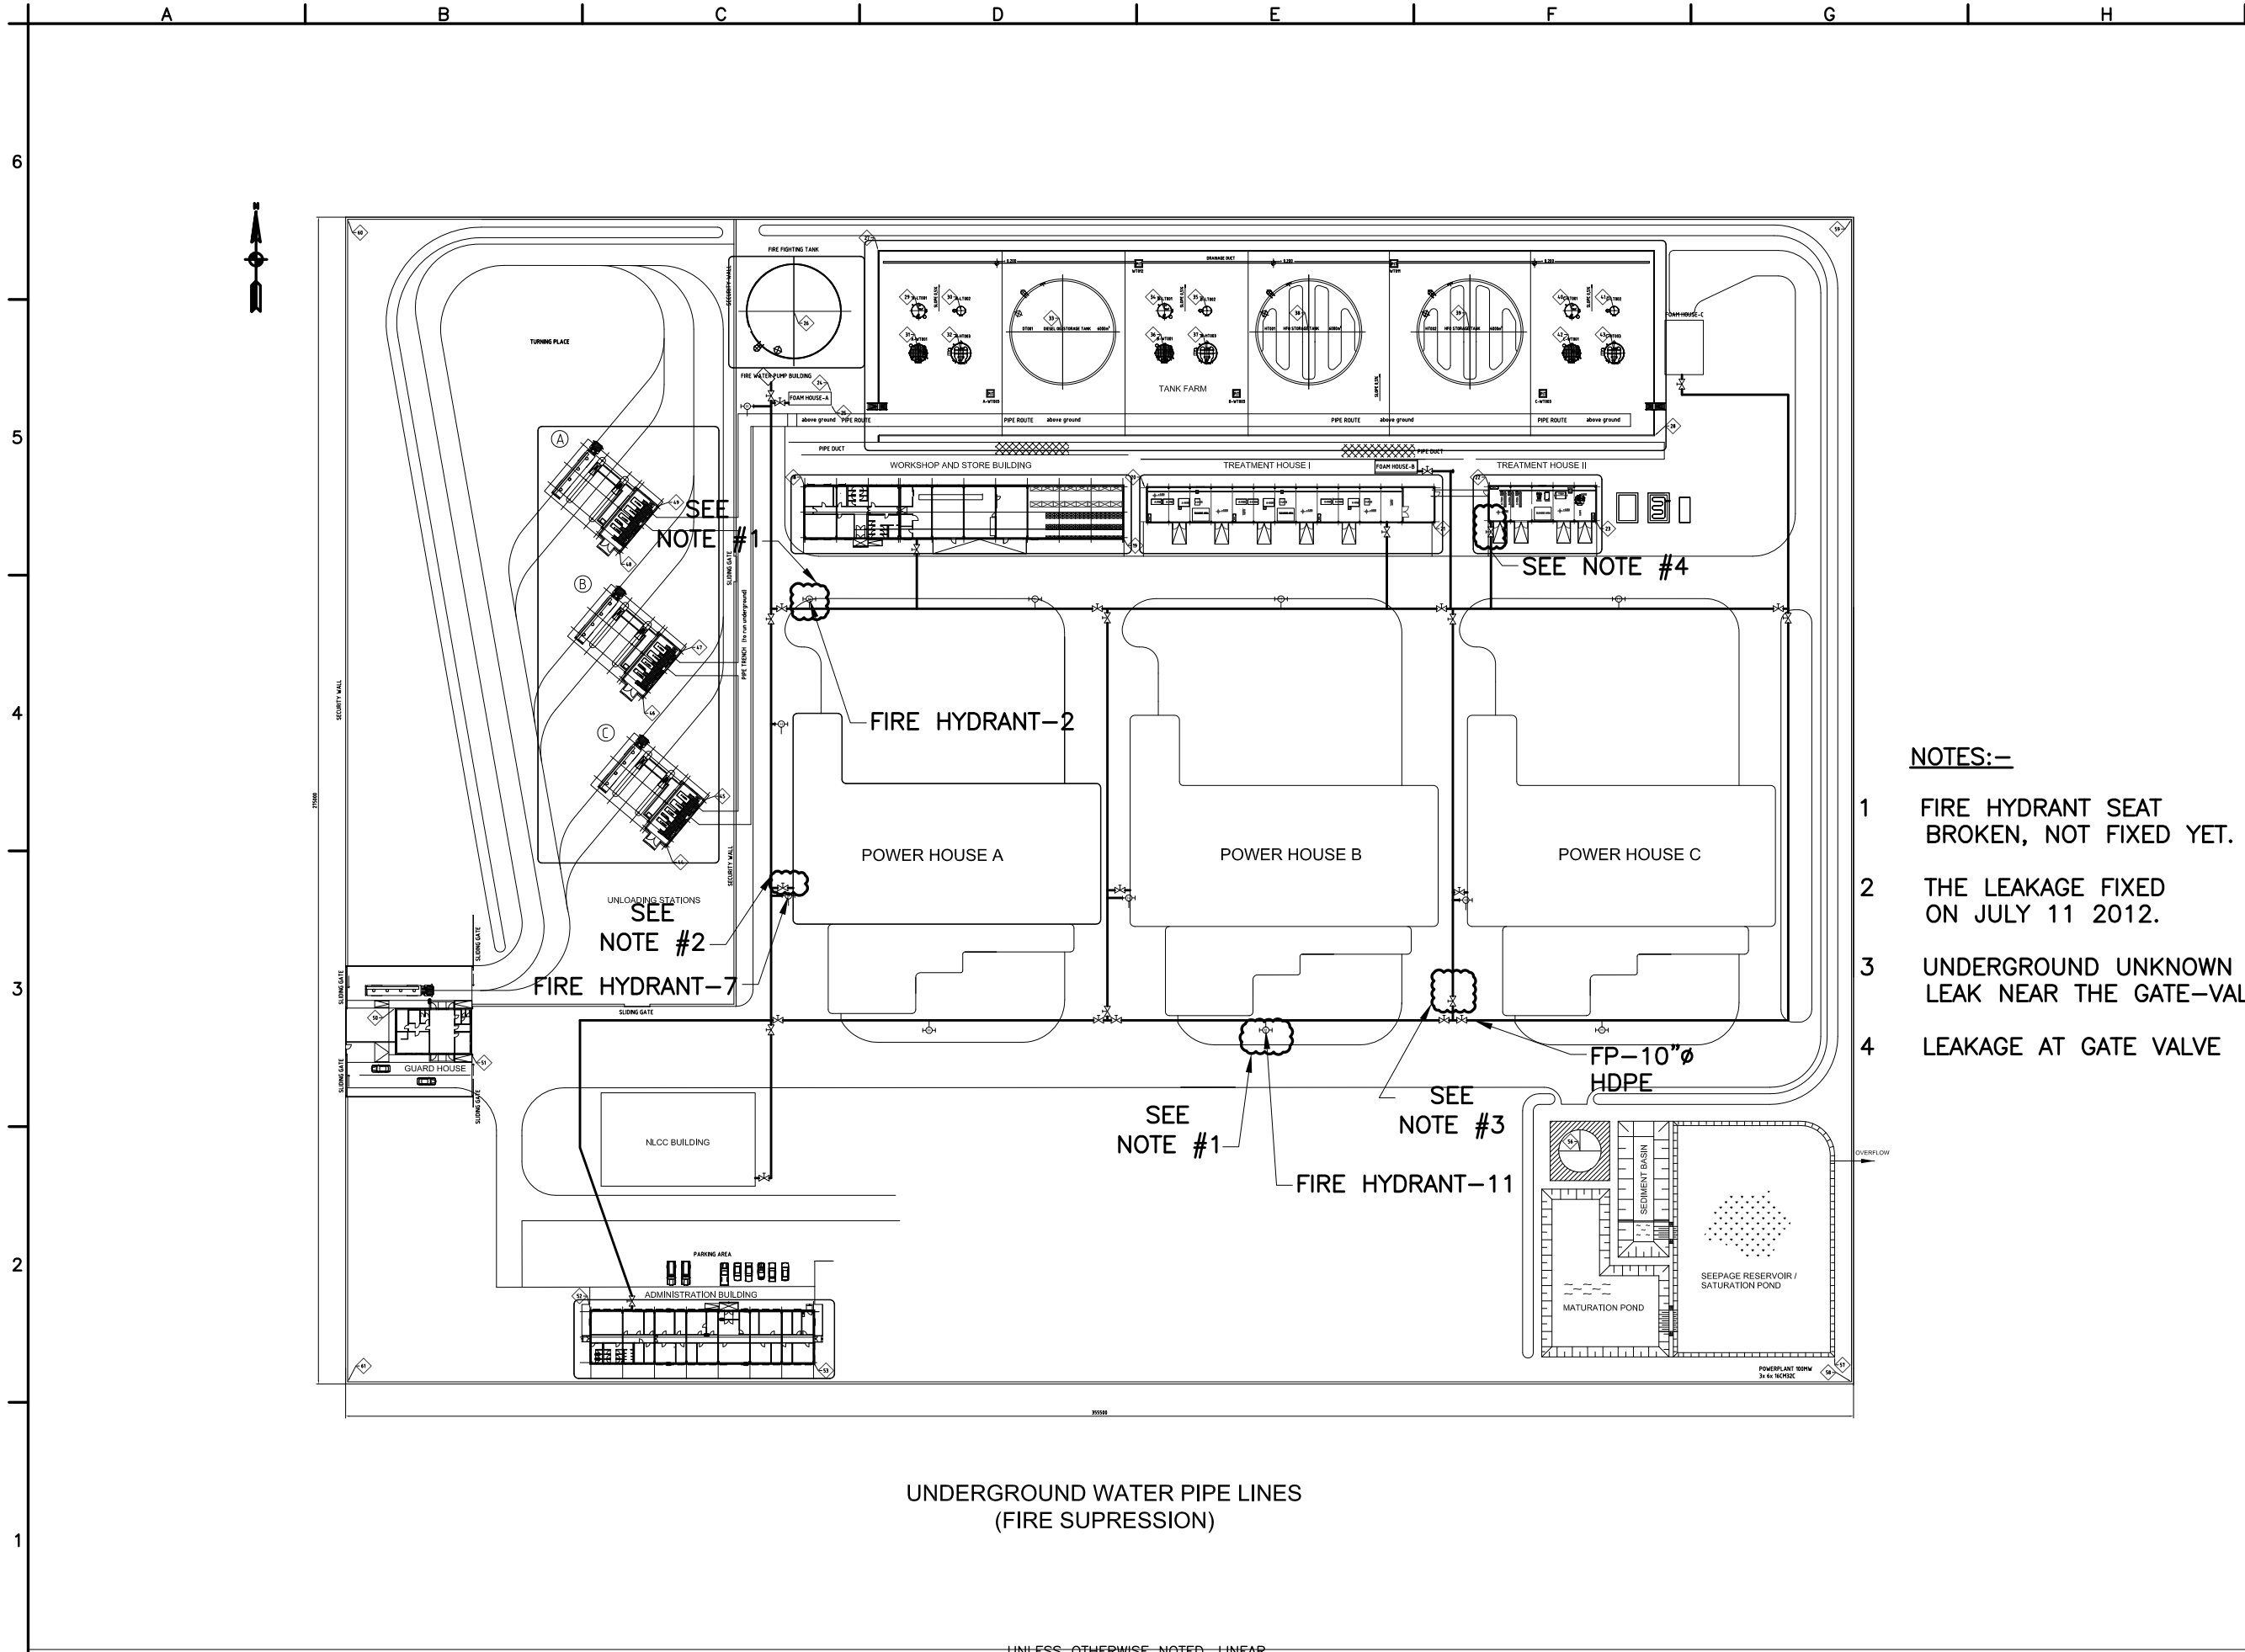
Appendix 3 Existing System Deficiencies

- Two (2) leaks are related to the seats of fire hydrants, DABS is having problems procuring spare parts;
- One (1) leak was in the 200 mm pipe connection to Power-House Building A, however, the leaking joint was excavated and re-fused on July 11, 2012;

- One (1) leak is in the above ground gate valve in the pipe connection to Treatment House #2; and
- One leak (1) is in the gate valve located near the southeast corner of Power-House Building C. The valve is covered by approximately twelve inches (12”) of concrete. When the valve leaks, water discharges up through the valve operator sleeve opening in the concrete. Since the leak has not been excavated, it is unknown if the leak is in the heat-fused joint or the valve flange connections. This area needs to be excavated to determine source of the water leak.

Refer to Appendix 3, “Existing System Deficiencies” for the location of the five (5) recorded system leaks.
